Alston Moor Partnership – Thermal Image Camera

Thermal Imaging Camera Report – Alice’s House Feb ‘20

By Gordon Monk and Tim Haldon – Alston Moor Partnership

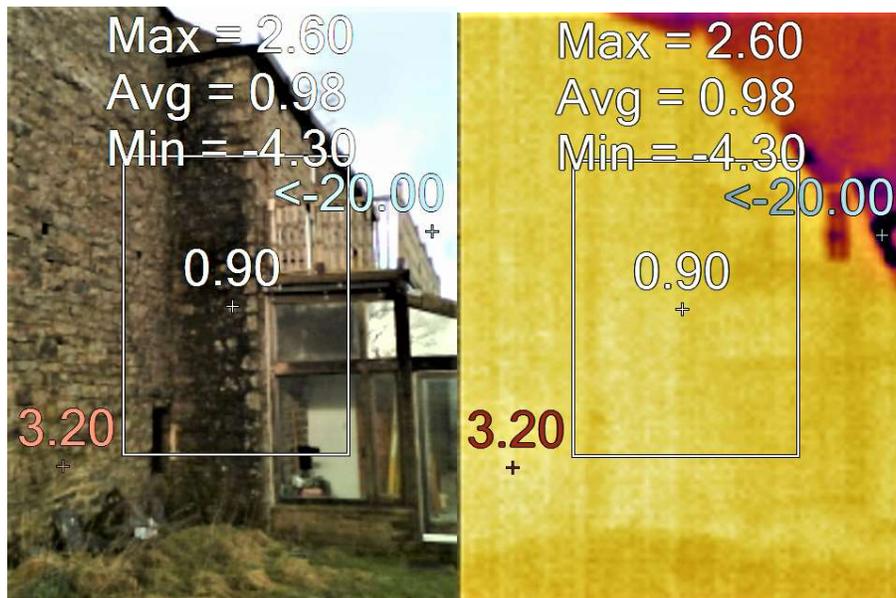
And this is what it shows – The numbers in these pictures are temperatures in degrees C.

Due to the very strong cold wind with intermittent sleet and the thickness of the walls of this traditional 1840’s stone built Mine Manager’s house there is not too much of a temperature differential displayed, however there are a few patches that are a degree or two above the ambient which should be checked and could indicate that some insulation on the internal wall could be advantageous.

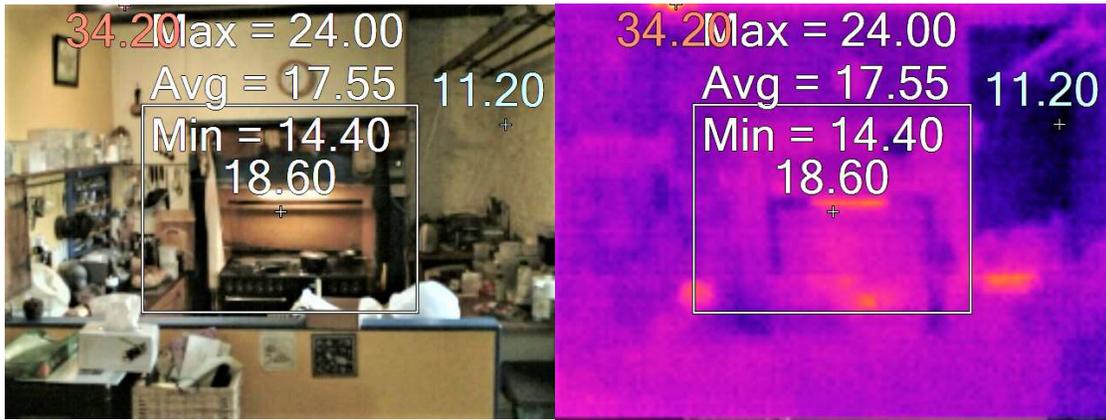
Looking from inside the house, we can clearly see that the outside wall to the right of the pictures is dark, indicating that it is several degrees colder than the rest of the room and that adding insulation here could make this corner a lot warmer. However, this area should be checked first to ensure that this difference in temperature is not due to rising or penetrating damp.

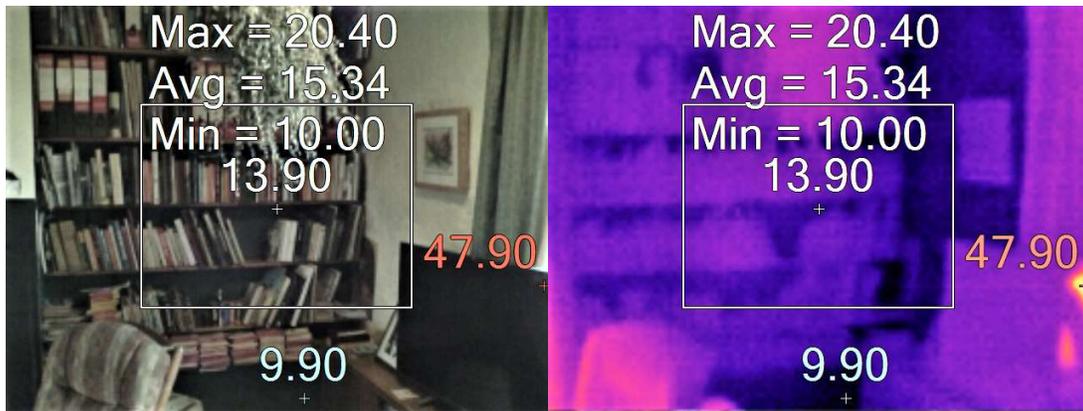
Likewise, on this picture the floor here and the wall behind the bookshelf is very dark and therefore several degrees colder, and both should be investigated to determine the cause. Note the chair to the lower left standing in front of the wood stove, and the reflection of the stoves heat on the TV showing a temperature reading of 47.9c!

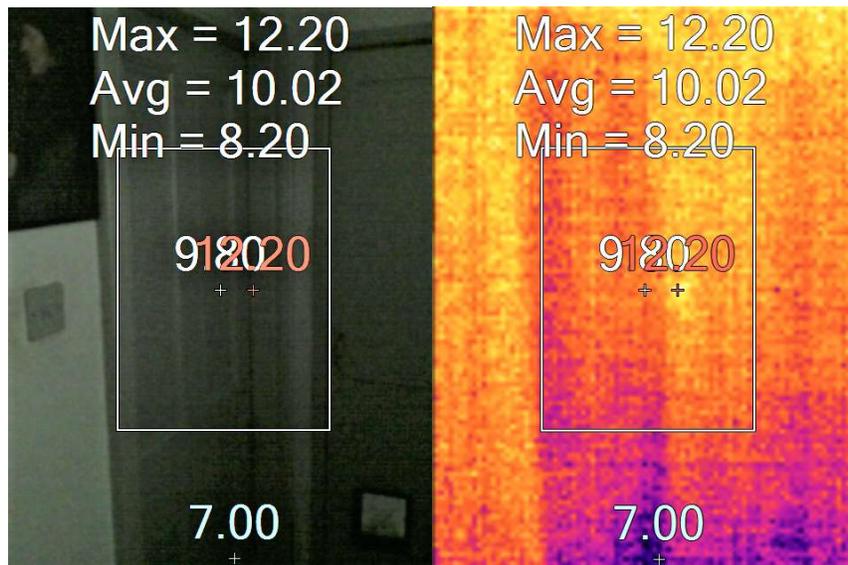
Here we can clearly see the cold draught from under the door to the unheated larder, and we can conclude that it would be worthwhile fitting a suitable draught excluder to the bottom of this door.

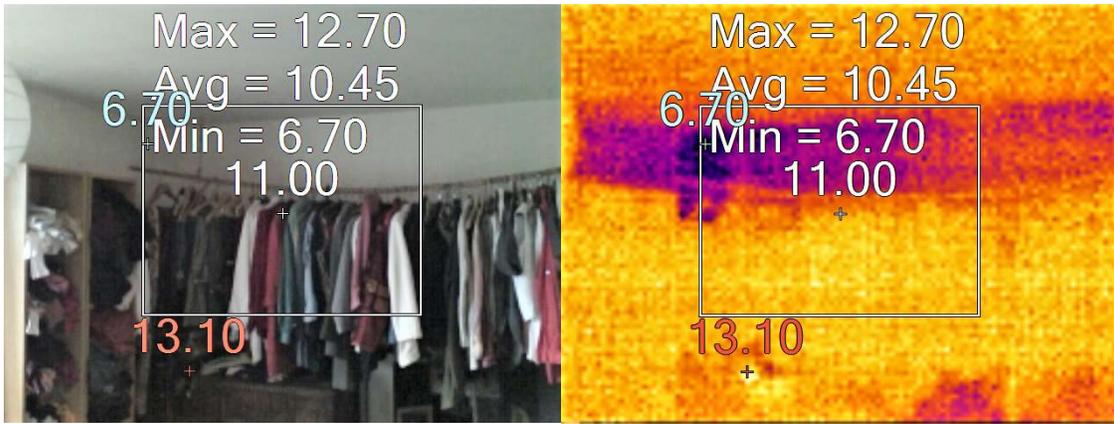
Upstairs we can see a dark patch in the corner of the room, which should be investigated as it could indicate some penetrating damp from above or outside, possibly caused by a problem with the guttering. However, the ceiling is warm, which considering the outside temperature shows that the loft insulation is doing its job effectively.

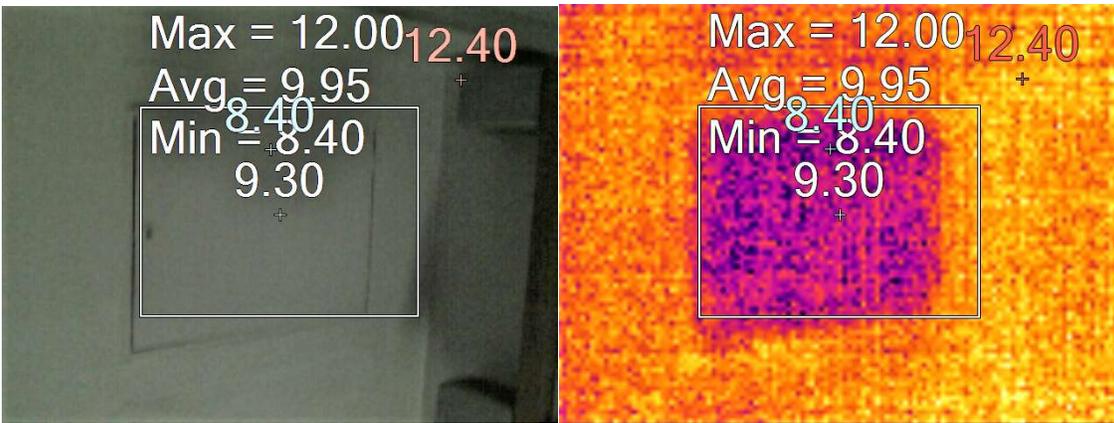
The lack of insulation on the loft hatch shows clearly, however the draught seal looks to be good.
